Veterinary Specialists of Alaska, P.C. Client Information Sheet: Pancarpal Arthrodesis

Pancarpal arthrodesis

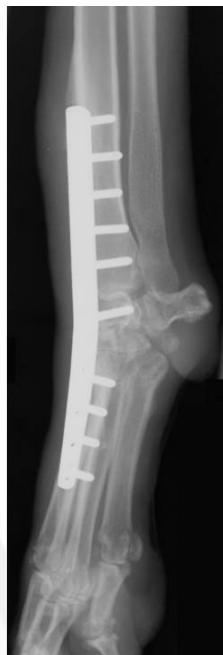
Surgery consists of removal of all joint cartilage, placement of a bone graft into the joint spaces and application of a specifically designed bone plate. (picture on the right). Recent literature* suggests that the use of a cast after pancarpal arthrodesis is not necessary anymore, especially since using the biomechanically more advanced new plates. However, a small bandage will be applied.
